HYUNDAI NEW THINKING. NEW POSSIBILITIES.	GROUP	NUMBER
	CAMPAIGN	15-01-035-1
Technical Service Bulletin	DATE	MODEL(S)
	OCTOBER 2015	TUCSON (TL)

SUBJECT: COLOR TOUCHSCREEN RADIO UPDATE
(SERVICE CAMPAIGN TY0)

DESCRIPTION: This bulletin describes the procedure for updating the Tucson color touchscreen audio system because it incorrectly displays navigation features on the instrument cluster.

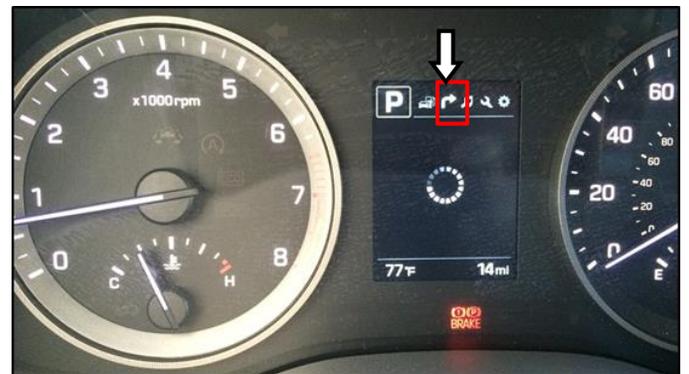
2. With the vehicle "ON", verify the Tucson is affected by the Instrument cluster display concern.

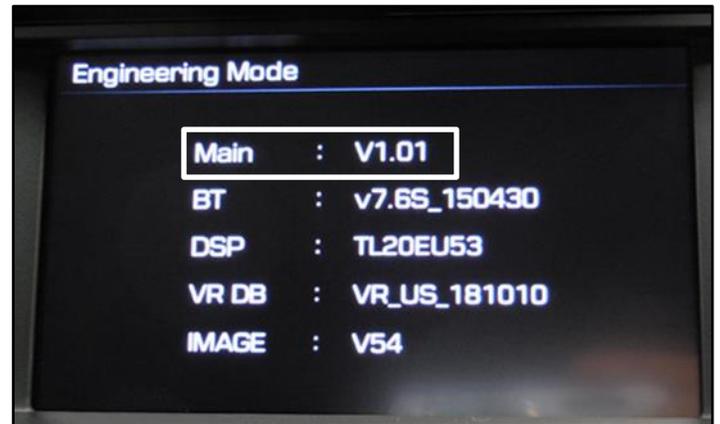
- If the current S/W version is equal to V1.01, continue to the S/W update step (6).

- Update = V1.01
- Do NOT Update ≠ V1.01

Do not update the radio if the current s/w version is not V1.01.

Updating a radio without V1.01 as the current version will permanently corrupt the radio.

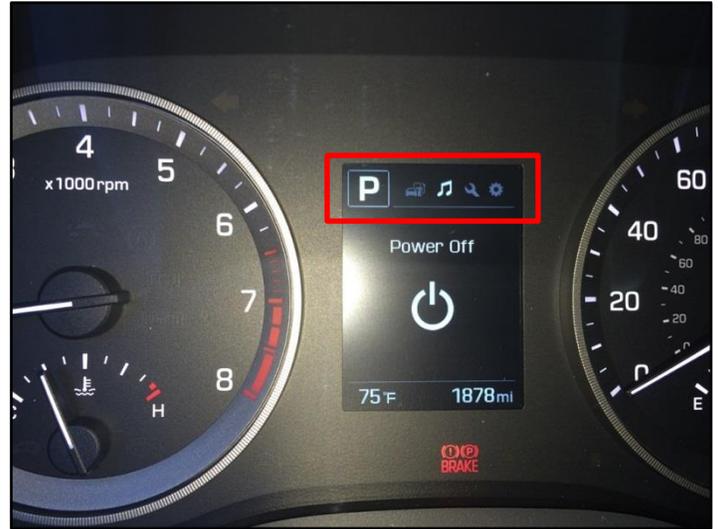
20. With the memory now cleared, set the ignition to "ON" and verify that the Navigation Tab is no longer shown on the instrument cluster.

If the instrument cluster information is accurate (no Navigation Tab) end service procedure here.

If the Navigation Tab is still shown and the Main version is updated to V1.02, retry the memory reset procedure with the fuse removed for 30 seconds.
