**HYUNDAI** | NEW THINKING.  
NEW POSSIBILITIES.

## Technical Service Bulletin

GROUP <b>CAMPAIGN</b>	NUMBER <b>16-01-028-2</b>
DATE <b>JULY 2016</b>	MODEL(S) <b>2016 TUCSON (TL)</b>

HOOD SAFETY HOOK CATCH REPLACEMENT  
AND CLUSTER UPDATE (RECALL 145)

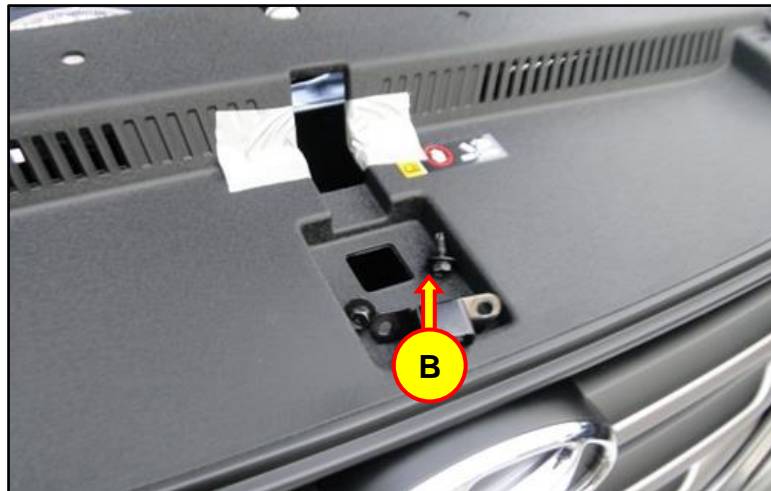
**Description:** On some 2016 Tucson (TL) vehicles, due to the tolerance stack-up between the secondary hood latch and catch mechanisms, the secondary hood latch can potentially disengage from the catch while driving **if the primary hood latch is released**. The condition may result in obscuring the driver's vision and increase the risk of crash.

8. Remove the hood safety hook catch (B) and install the replacement hood safety hook catch. Reinstall all the removed parts in reverse order of removal. Remove the masking tape.
